# Manhole Inspection Summary

Manhole # S21KK\_008MH

**Location** Address: **1617 CLIFTON AVE**

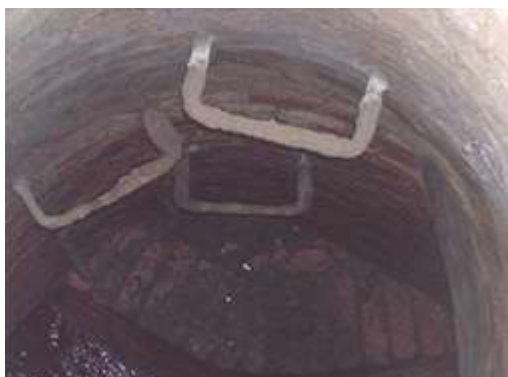
Defect 3

Count: **4** Missing: **0** ☒ **Corroded**

CORRODED STEPS

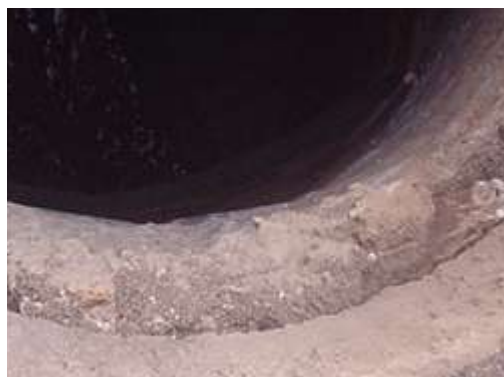
Defect 2

Offset: **2** (in.)

FRAME OFFSET

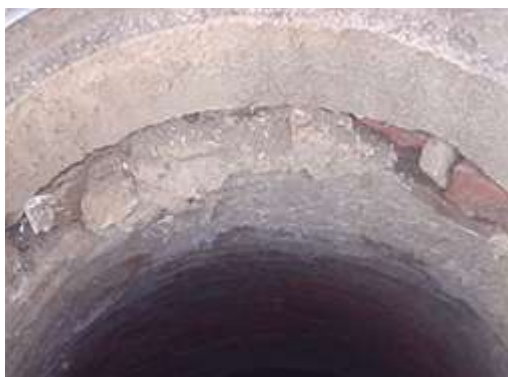
Defect 1

Condition: ☐ Sound ☐ Cracked ☐ Root Intrusion ☐ Loose Brick ☒ **Deteriorated**

DETERIOATION OF CHIMNEY

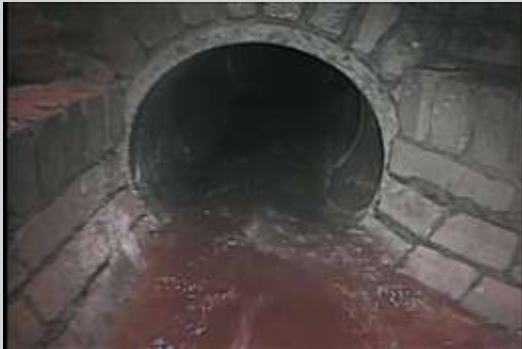
12 O'Clock Outflow

15 in. Circular Gravity Sewer  
Pipe Out @ 12 O'Clock

Pipe Height: **15.6** (in.) Rod and Bar (Angled)  
Pipe Material: **Clay** ☐ Pipe Lined  
Invert Depth: **9.94** (ft.) Flow Characteristics: **Slow**  
Deposits: ☒ None ☐ Mud ☐ Sludge ☐ Debris ☐ Grease  
Silt Depth: (in.) Deposits Extent:  
Infiltration: **None** Pipe Seal Cond: **Sound**

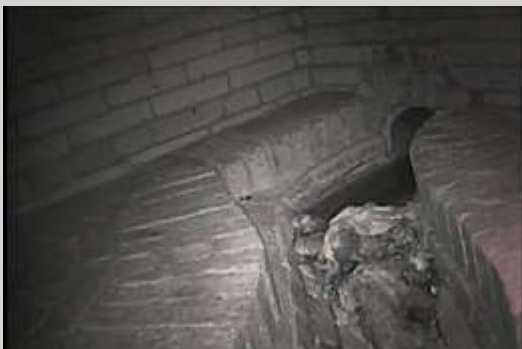
5 O'Clock Inflow

8 in. Circular Gravity Sewer  
Pipe In @ 5 O'Clock

Pipe Height: **8.4** (in.) Rod and Bar (Angled)  
Pipe Material: **Clay** ☐ Pipe Lined  
Invert Depth: **9.74** (ft.) Flow Characteristics: **Slow**  
Deposits: ☒ None ☐ Mud ☐ Sludge ☐ Debris ☐ Grease  
Silt Depth: (in.) Deposits Extent:  
Infiltration: **None** Pipe Seal Cond: **Sound**

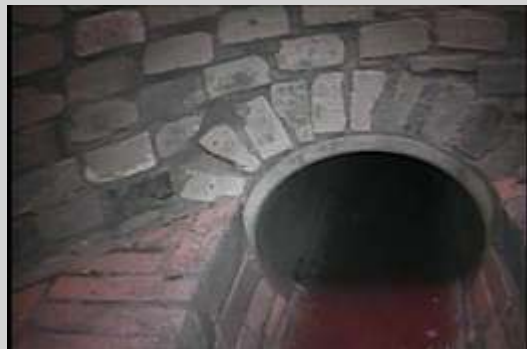
8 O'Clock Inflow

15 in. Circular Gravity Sewer  
Pipe In @ 8 O'Clock

Pipe Height: **15.6** (in.) Rod and Bar (Angled)

Infiltration: **None** Pipe Seal Cond: **Sound**
